# **Arkansas River Corridor Projects River Bank Stabilization and Concept Design**

| TO: | Tulsa County |
|---|---|
| PREPARED BY: | CH2M HILL |
| DATE: | March 26, 2010 |
| PROJECT NUMBER: | 386594 |

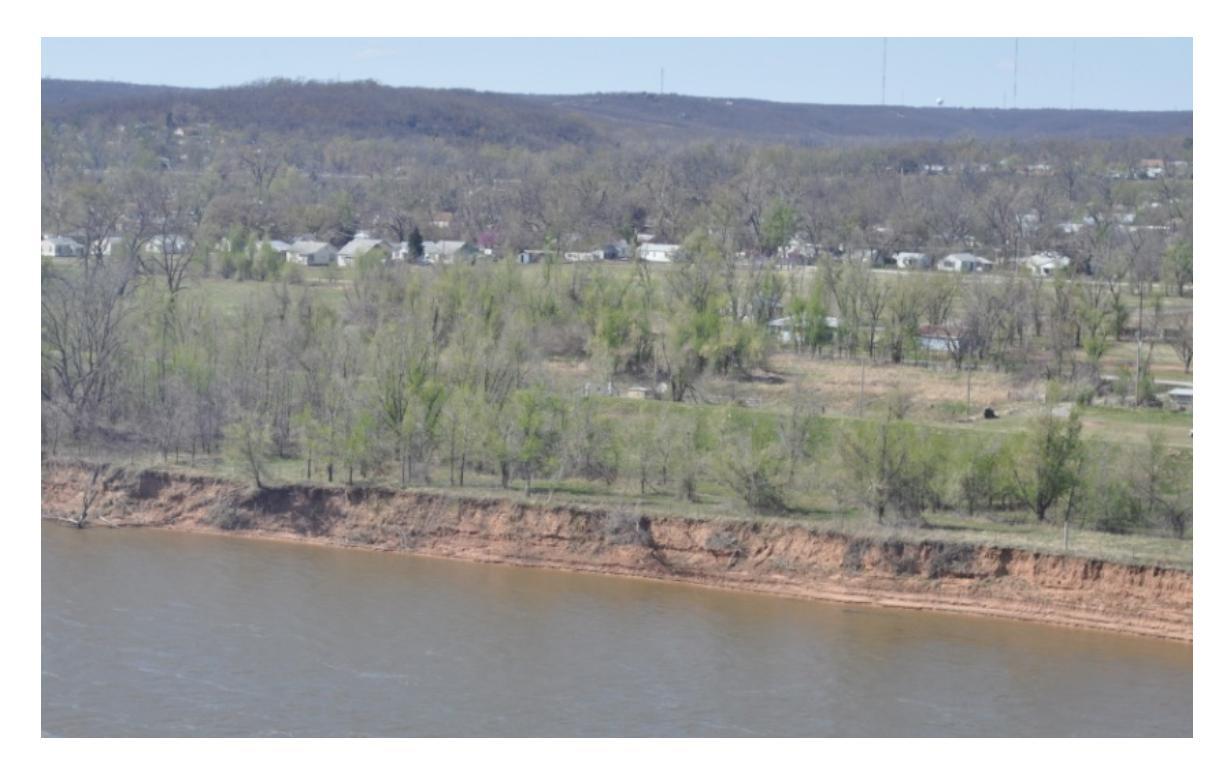
Photo 173 (Appendix A) shows extensive bank erosion along a relatively high, steep bank. Given the relatively uniform slope of this denuded bank, it appears that this bank erosion has been taking place for a relatively long period of time. Some active erosion and shallow slips can be seen, so the bank slope is still attempting to develop stability in equilibrium with the local hydrology and fluctuating water surface elevations in the river. Without conducting a detailed geotechnical analysis of this bank, it is difficult to determine exactly what a stable bank slope would be for the local soil characteristics and hydraulic regime.

PHOTO 173 Extensive unstable bank, high erosion rate: significant bank height with steep, denuded slope

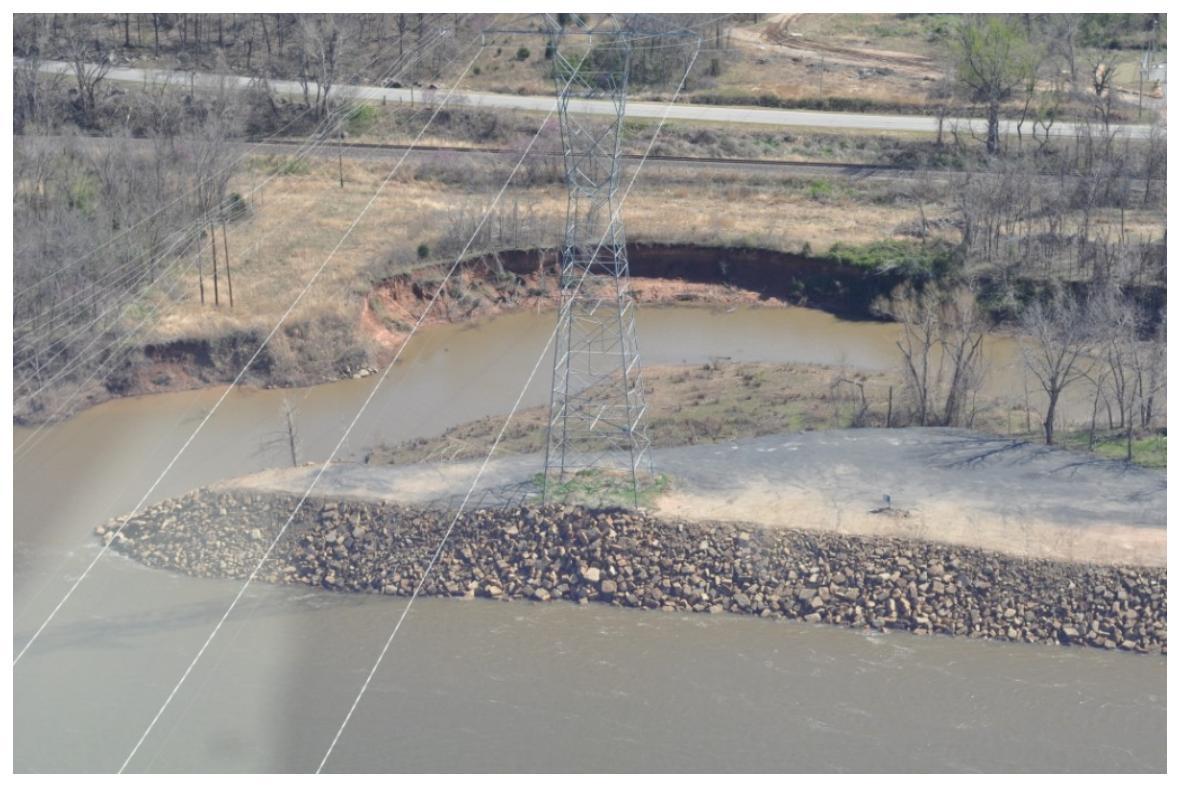
PHOTO 184 Localized unstable bank, high erosion rate: significant bank height with steep to vertical, denuded slope

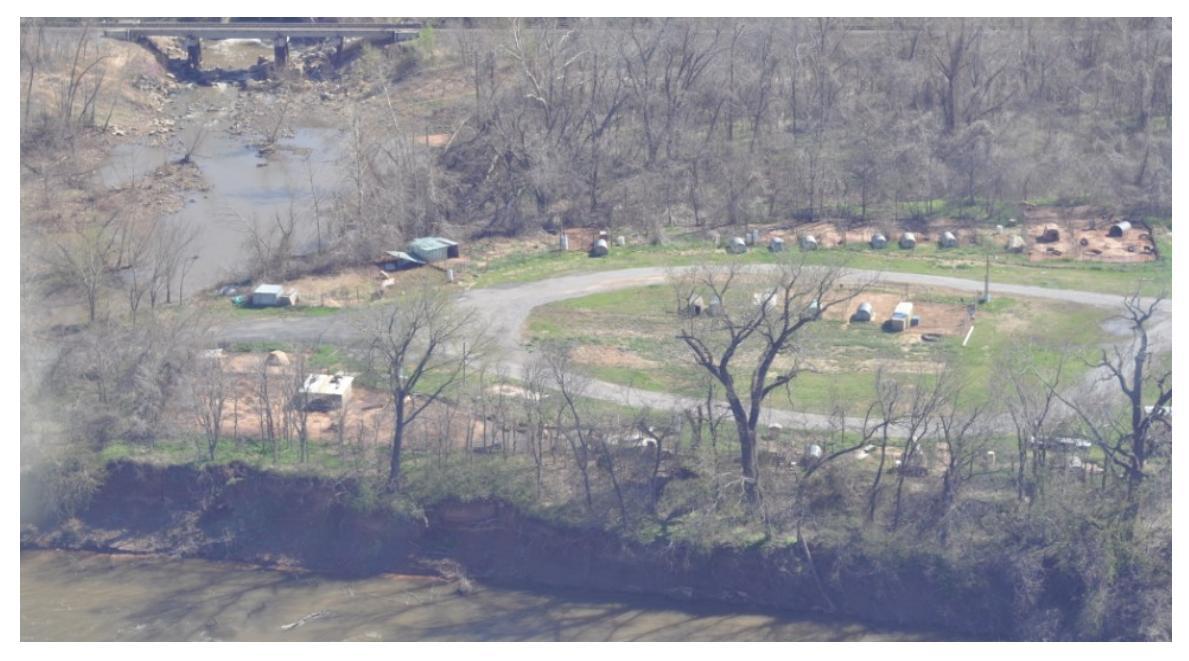
Photo 185 (Appendix A) shows a combination of toe scour and cantilever failure. The right portion of the photograph shows a near vertical bank, with cantilevered material at the top. The cantilevered material is tenuously held in place, likely due to root density and perhaps slightly more cohesive soils in the upper layers. Previously failed bank material from this location has been entrained by the river, exposing the toe to another cycle of erosion. The bank on the left side of the photograph still has previously failed material at the toe, although the upper bank has retreated further inland than the adjacent bank.

**PHOTO 185** Extensive unstable bank, high erosion rate: significant bank height with steep to vertical, denuded slope

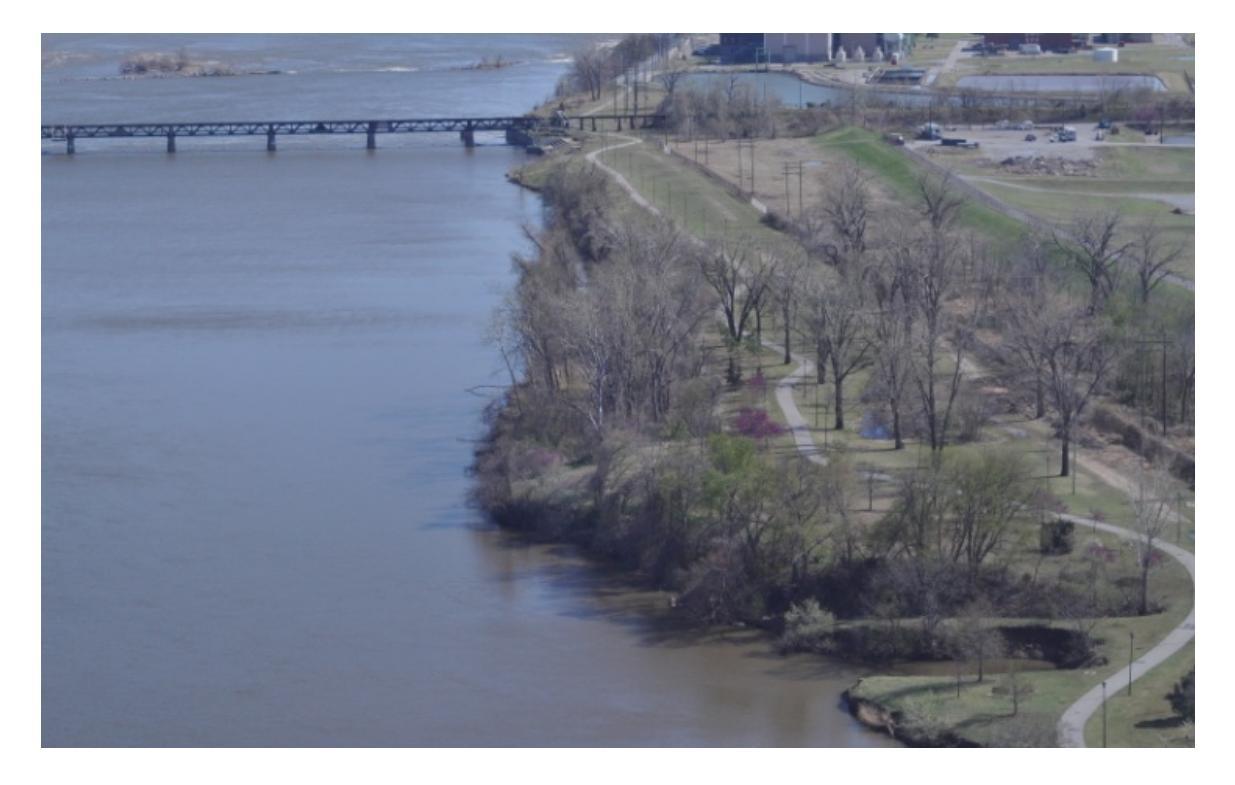
**PHOTO 275** Localized unstable bank, high erosion rate: close to infrastructure (lower right corner of photo)

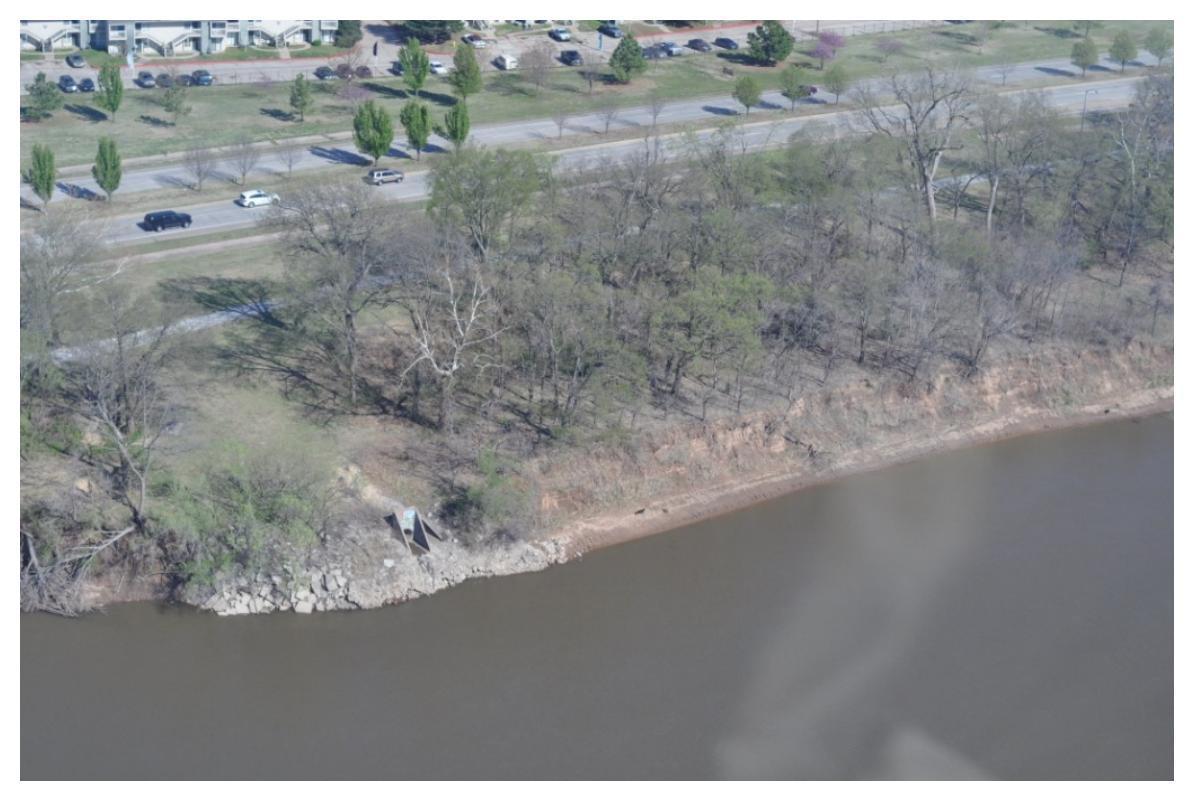
PHOTO 291 Unstable bank, high erosion rate: steep, high, denuded bank close to infrastructure; flanking and undercut potential

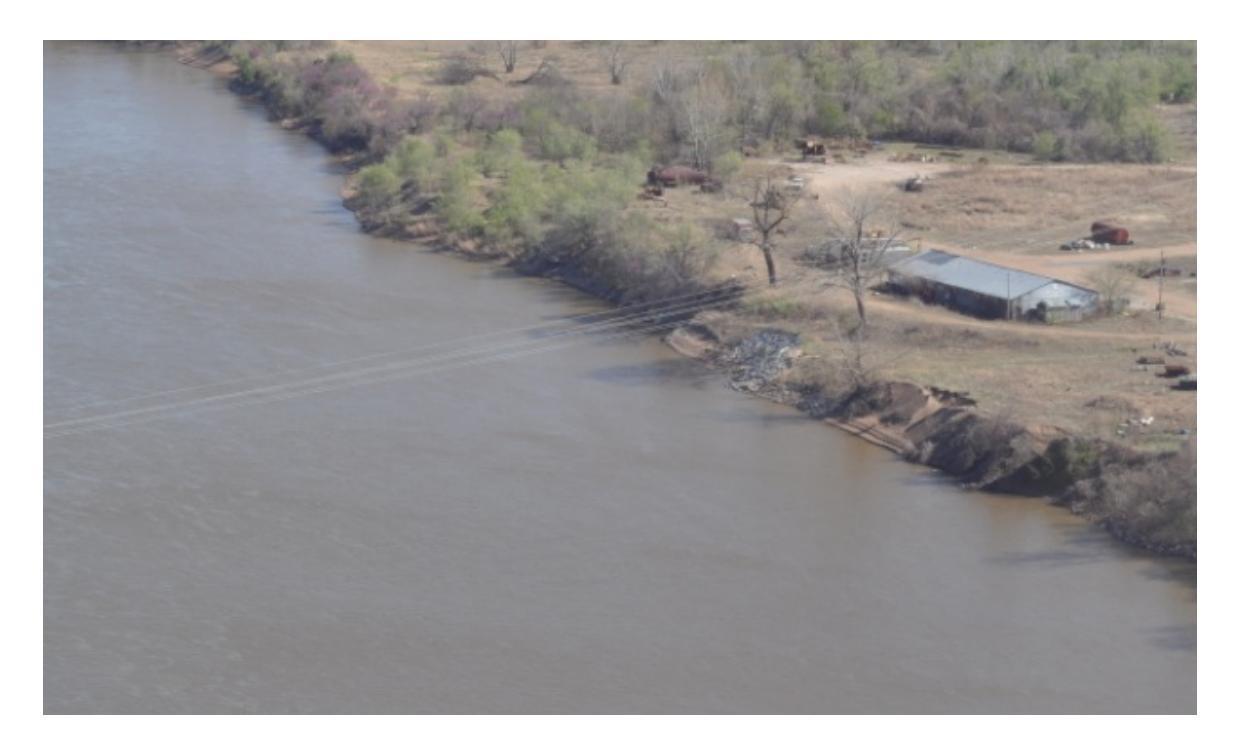
PHOTO 299 Local, active bank slumping, opportunity to stabilize prior to extensive lateral bank failure

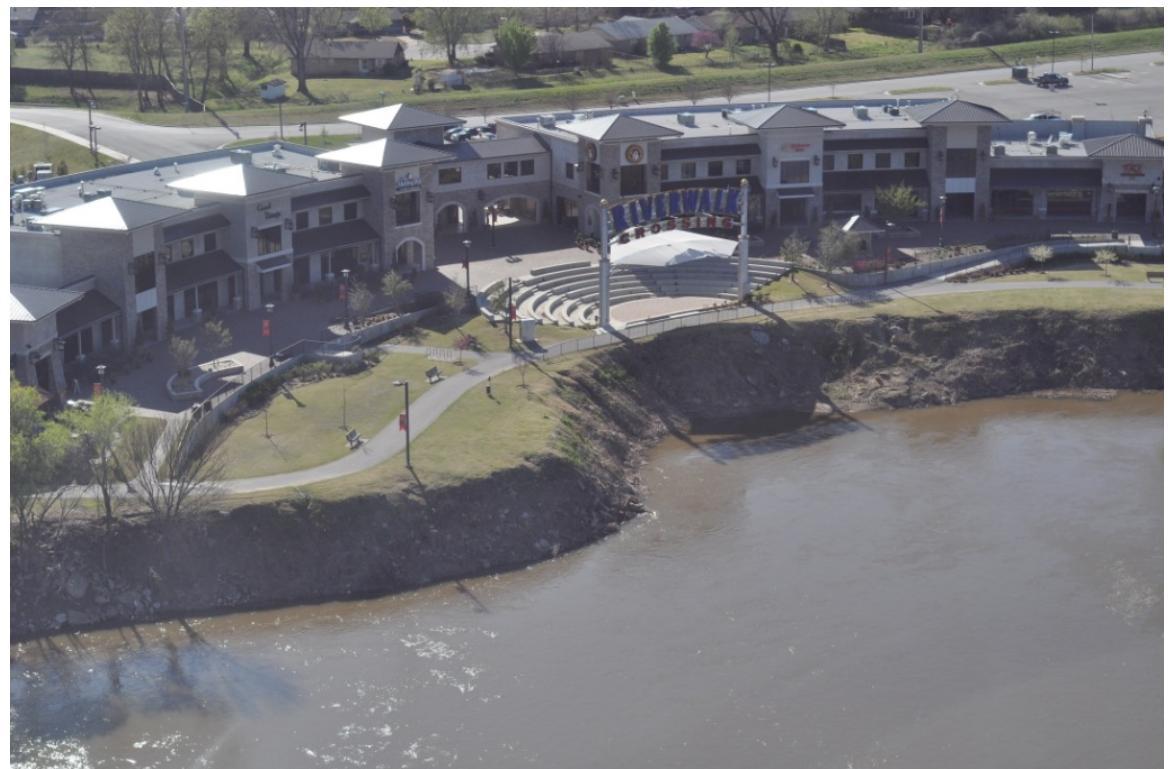
PHOTO 430 Steep, high bank experiencing mass failure near infrastructure

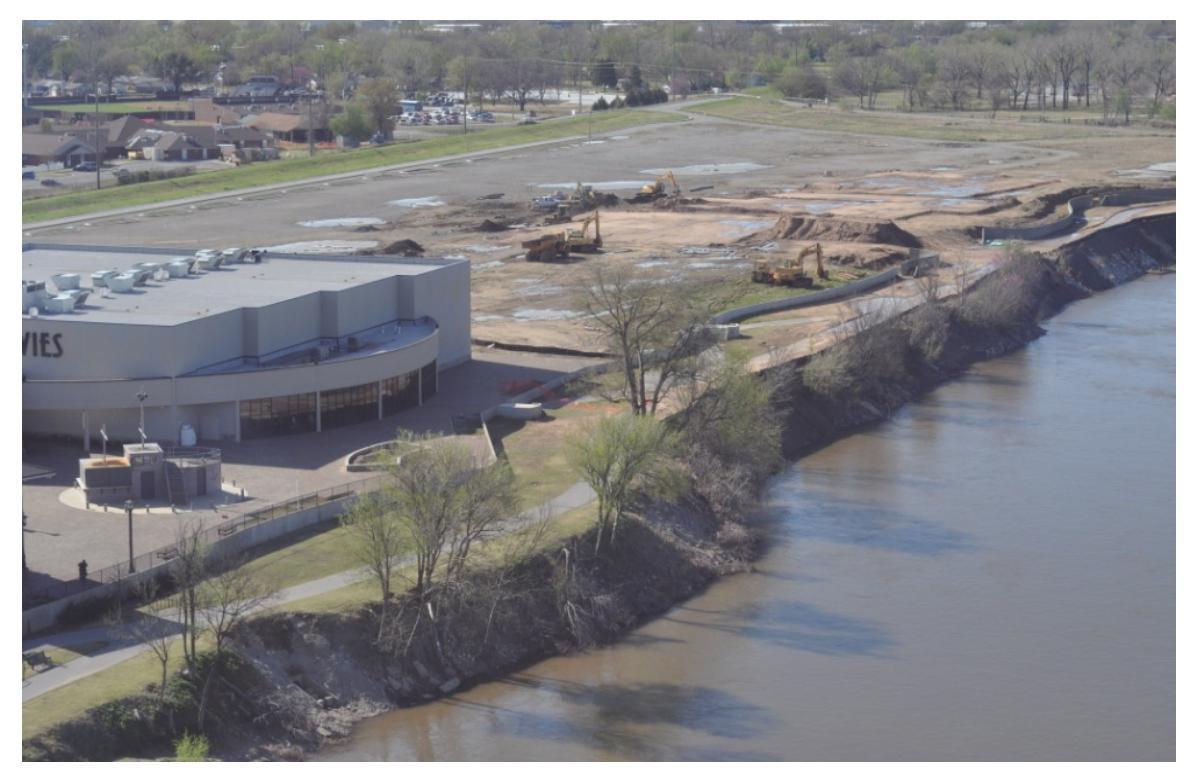
#### PHOTO 431 Over-steepened, high bank, erosion, and mass failure associated with infrastructure (storm pipe outlet at lower left)

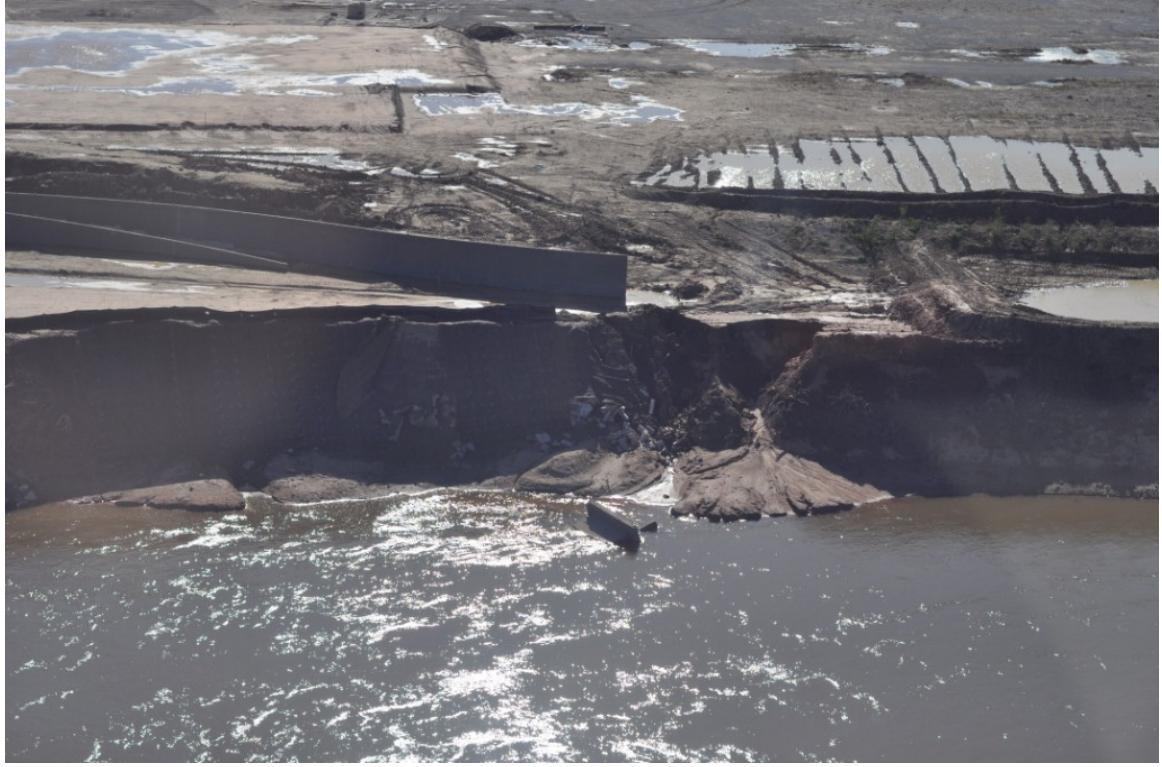
#### **PHOTO 434**

Unstable bank, high erosion rate: steep, high, denuded bank exhibiting overbank failure and rotational slumping
