Arkansas River Corridor Projects Site Reconnaissance Summary

TO:	Tulsa County
COPIES:	File
FROM:	CH2M HILL
DATE:	April 30, 2009
PROJECT NUMBER:	386594

This Technical Memorandum describes the site reconnaissance activities and summarizes the findings relative to potential human and natural environmental constraints to the conceptual design and permitting of the proposed project.

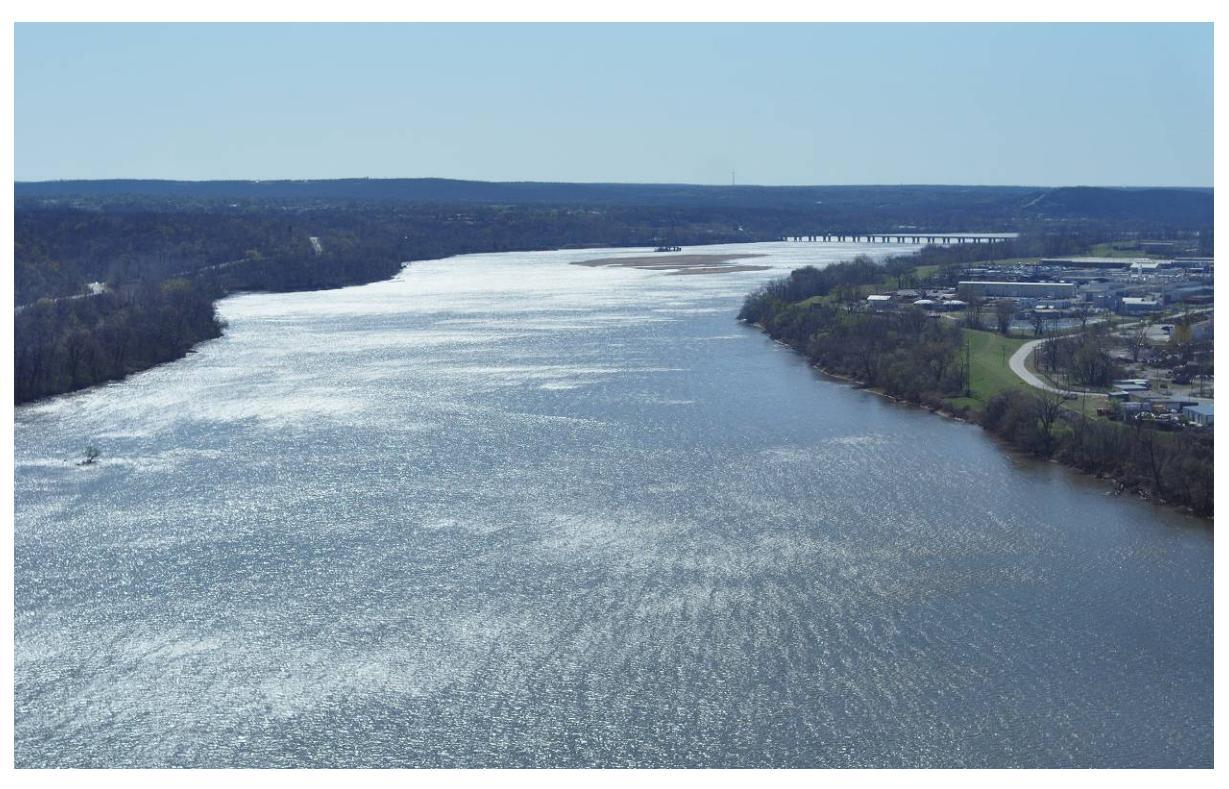
Figure 1. Upstream View toward Sand Springs and the Highway 97 Bridge

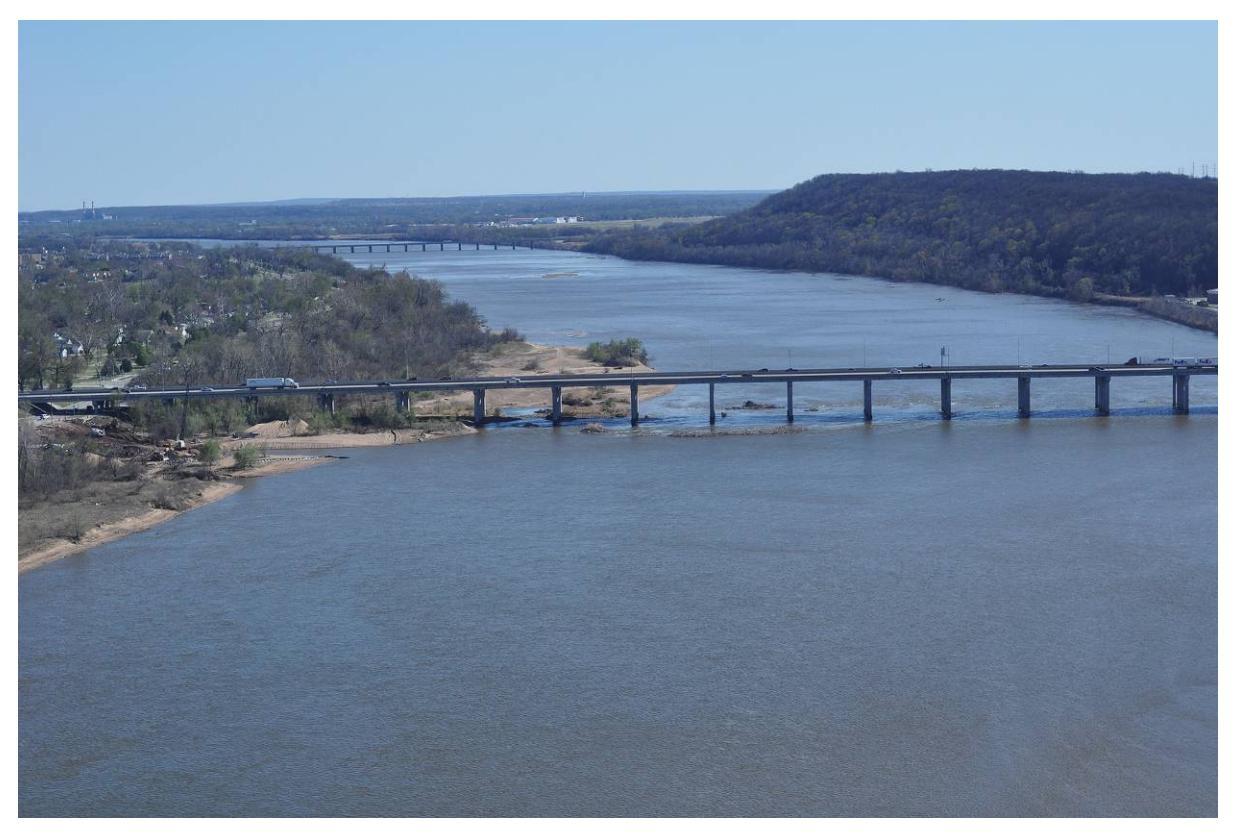
Upstream of Tulsa, the Northern Cross Timbers ecoregion is characterized by low, forested ridges and hills, many with steep, rocky faces (cuestas) bordering the Arkansas River floodplain, particularly between Keystone Dam and Sand Springs (Figure 1). Downstream of Tulsa, the Northern Cross Timbers ecoregion gives way to the Osage Cuestas ecoregion, especially downstream of Jenks as the river turns in a southeasterly direction. A prominent feature along the eastern edge of the Northern Cross Timbers is Turkey Mountain along the west shoreline downstream of Zink Dam between the I-44 and 71st Street bridges (Figure 2).

Figure 2. Downstream View of the I-44 Bridge and Turkey Mountain

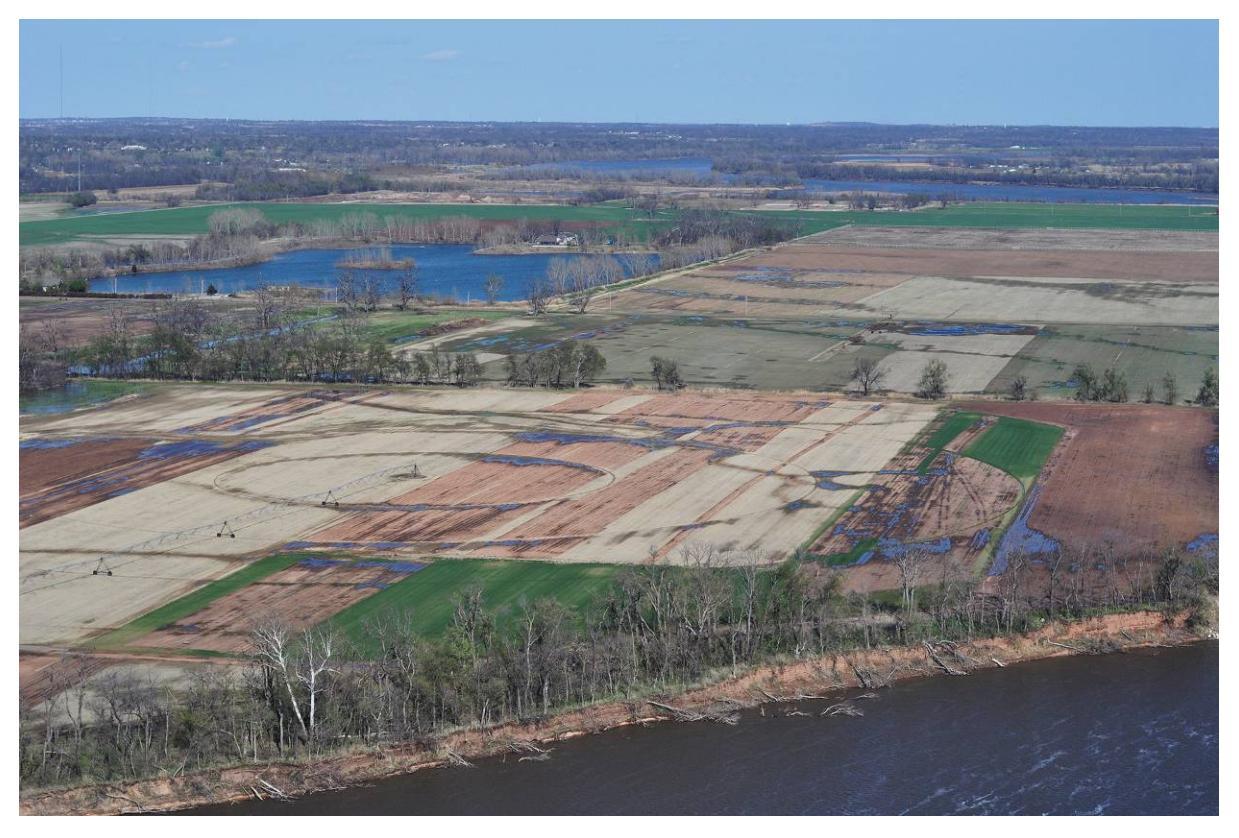
The Osage Cuestas ecoregion downstream of Jenks is characterized by low, forested hills and cuestas and a much greater prevalence of undulating plain (Figure 3).

Land uses between Jenks and the Tulsa County-Wagoner County line include a mix of woodland, farmland, rural residential land, and railroad uses, as well as localized industrial and commercial land uses. Croplands are common including large tracts of sod farms observed along the river between Jenks and the Wagoner County line (Figure 3).

Figure 3. Downstream View of Sod Farm along East/North Shore at South Garnett Rd

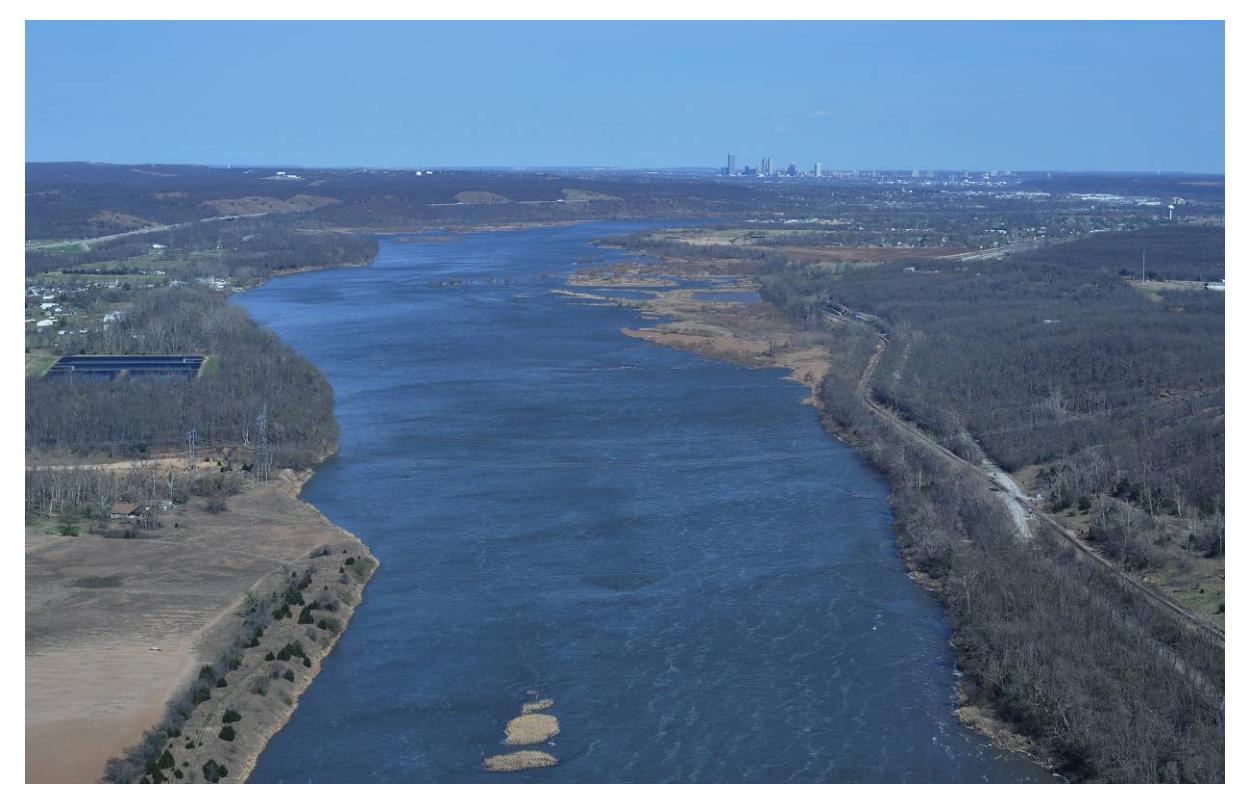
Figure 4. Downstream View from Sand Creek toward Fisher Bottom (on Right)

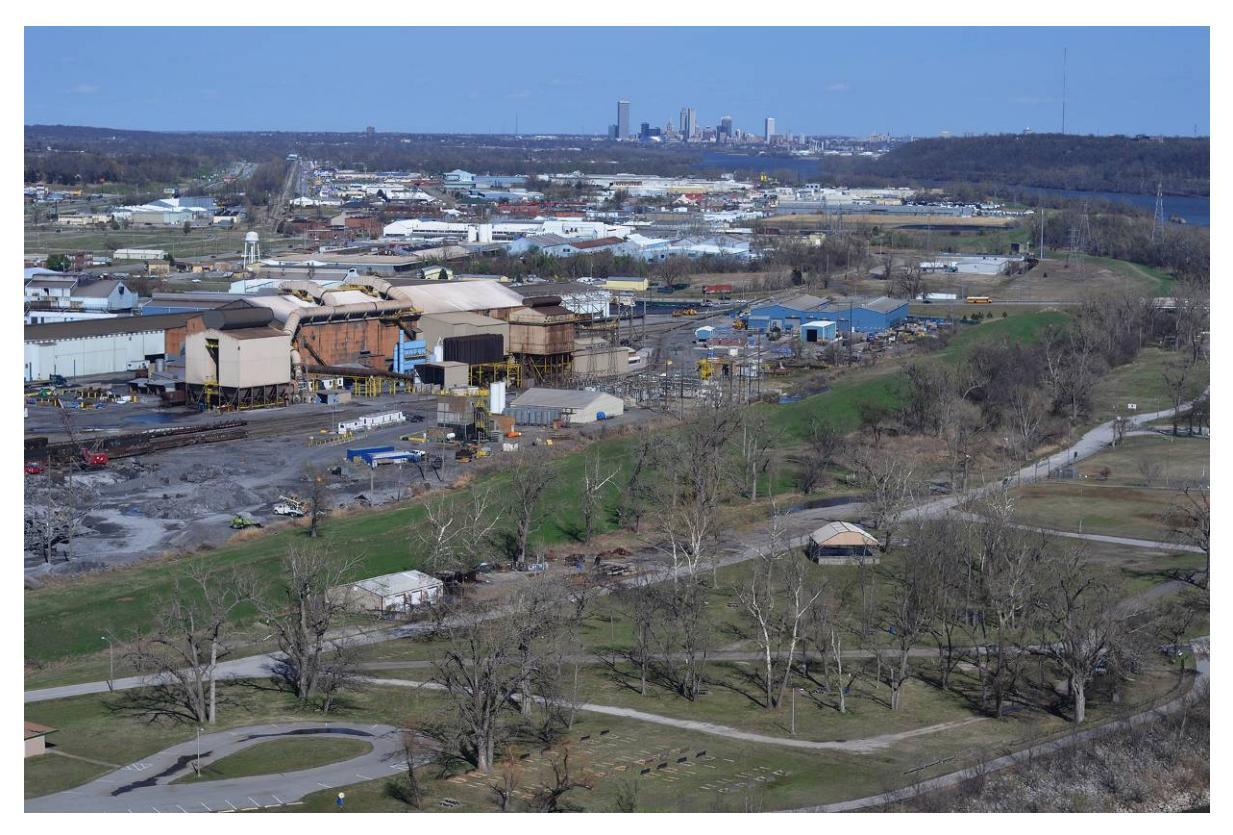
The floodplain in the upstream portion of the study area, between Keystone Dam and Sand Springs, is relatively broad and sandy and contains well developed riparian vegetation in many areas, including tracts of riparian forest. The floodplain in this reach is widest along the inside bends of the river, including the north shore just downstream of Keystone Dam, the south shore at Fisher Bottom (Figure 4), and the north shore at Sand Springs. These areas are occupied by open lands and homes upstream of Sand Springs and by commercial, industrial, and residential areas in Sand Springs. The wide floodplain at Sand Springs along the north shore is protected by a levee (Figure 5), which extends downstream toward Tulsa.

Figure 5. North Riparian Zone Industrial Area at Highway 97 Bridge in Sand Springs with River City Park in the foreground

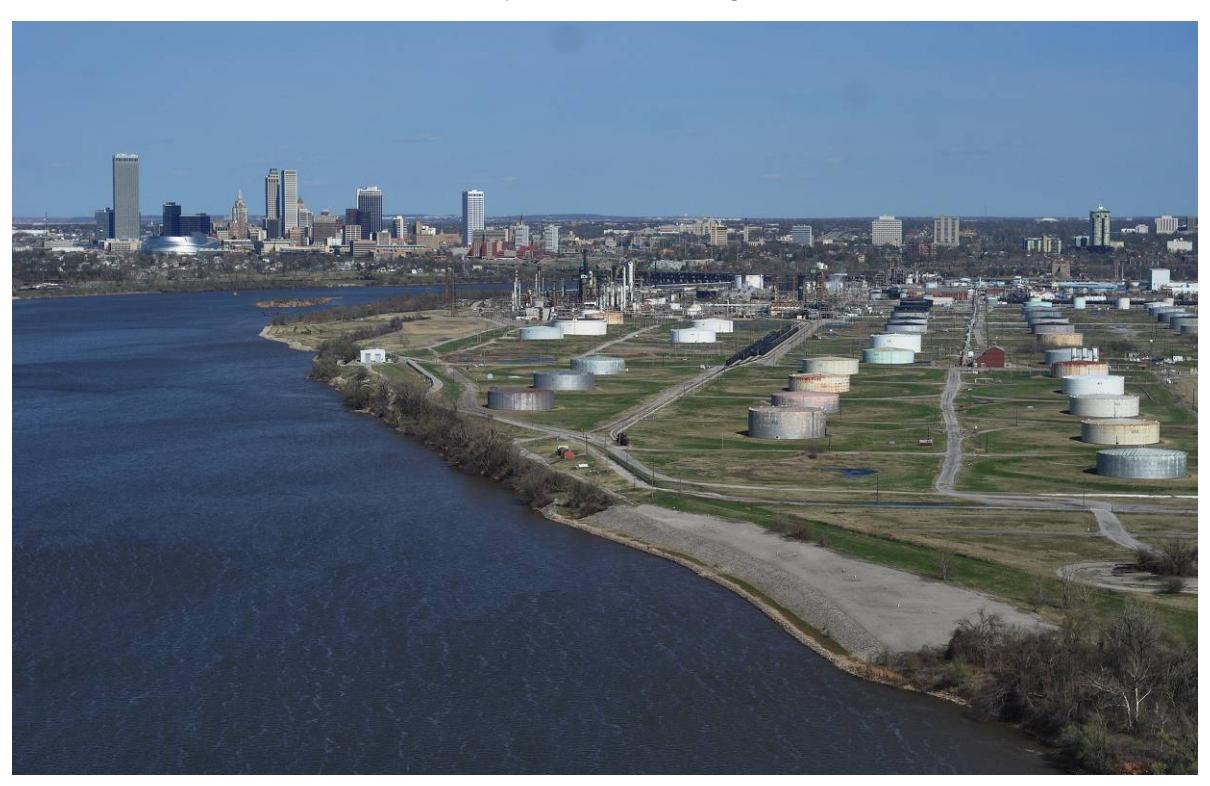
Figure 6. Downstream View of South/West Shoreline and Sunoco Oil Refinery

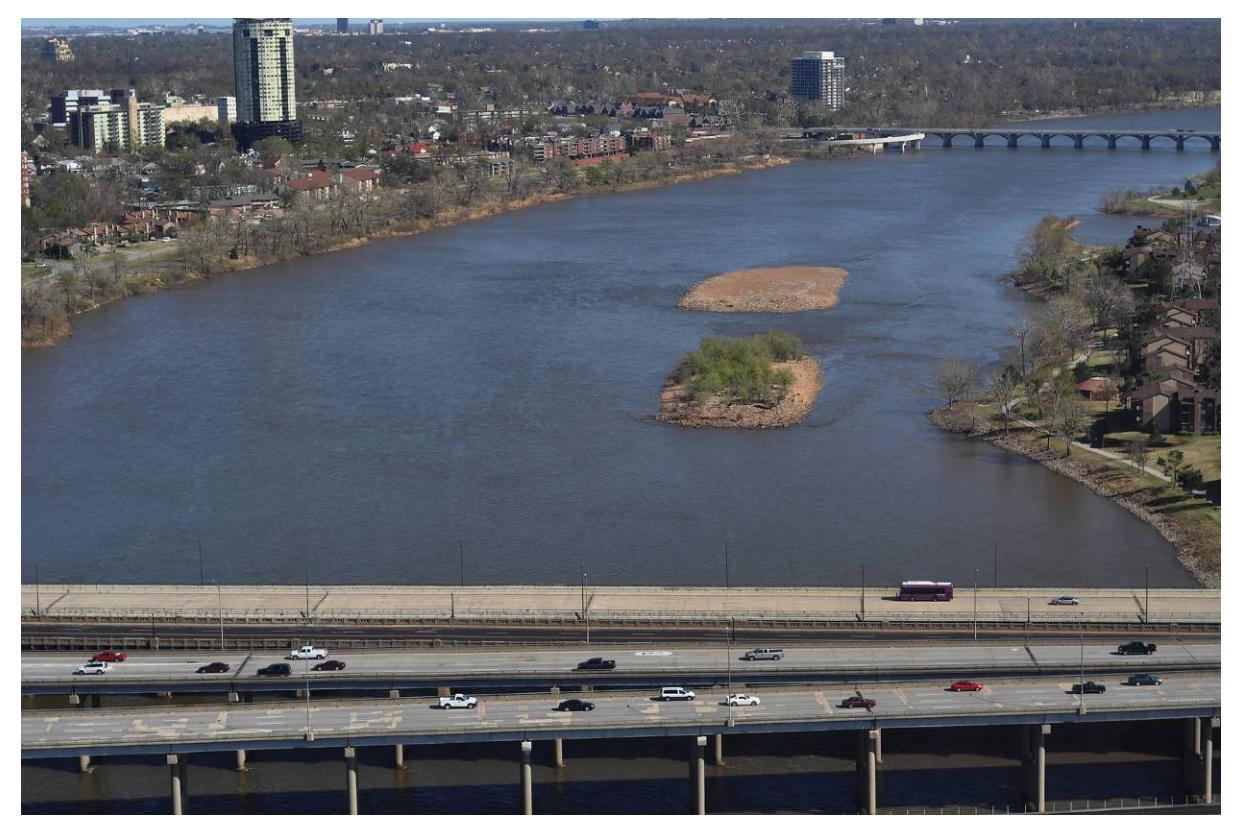
Exposed sandbars at this river flow were common in the reach between Keystone Dam and Sand Springs, including Fisher Bottom and a wide mid-channel sand bar just downstream of the proposed site of the Sand Springs low-head dam (Figure 15). Sandbars were most pervasive in the reach between Jenks and the Tulsa/Wagoner county line. Sandbars also were present but generally less extensive in the north-south reach of the river between Tulsa and Jenks. Portions of two islands in the upstream end of the Zink pool were exposed (Figure 7).

Figure 7. Downstream View from I-244 Bridge in Tulsa, including Zink Islands

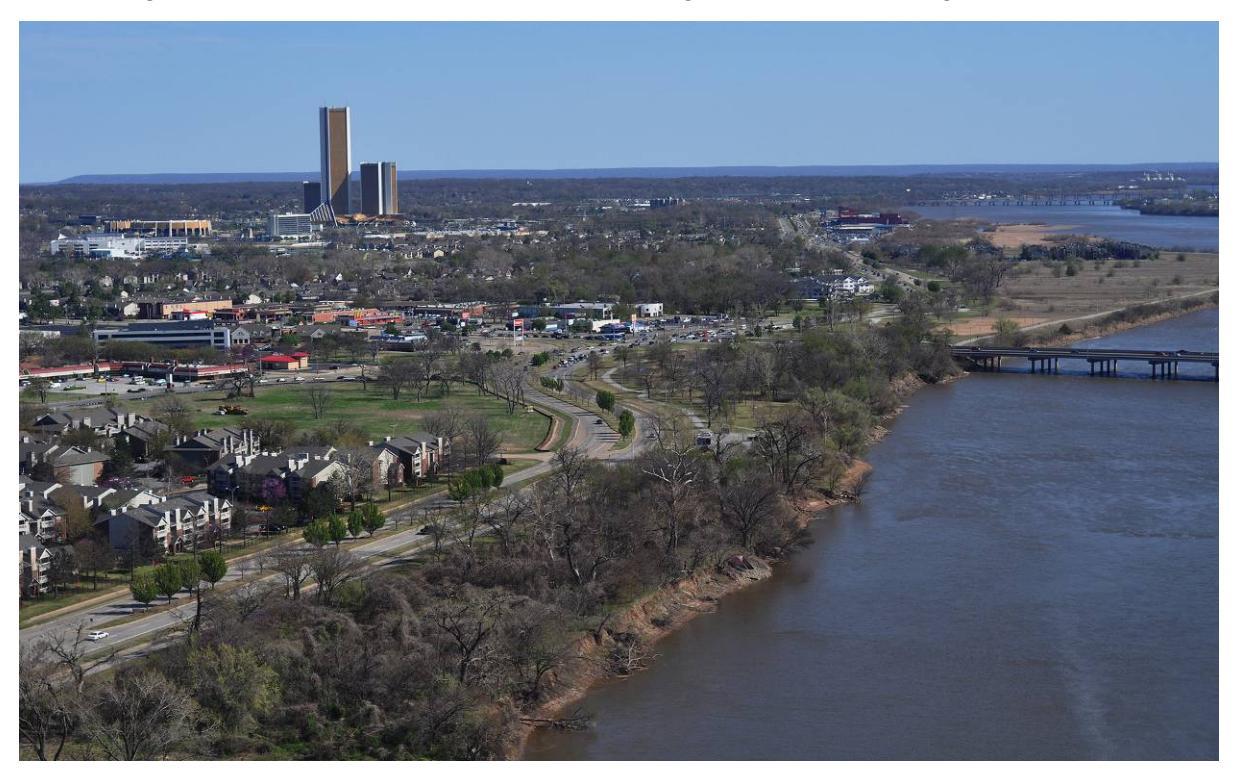
Figure 8. Downstream View of East Shoreline toward 71st Street Bridge in Tulsa

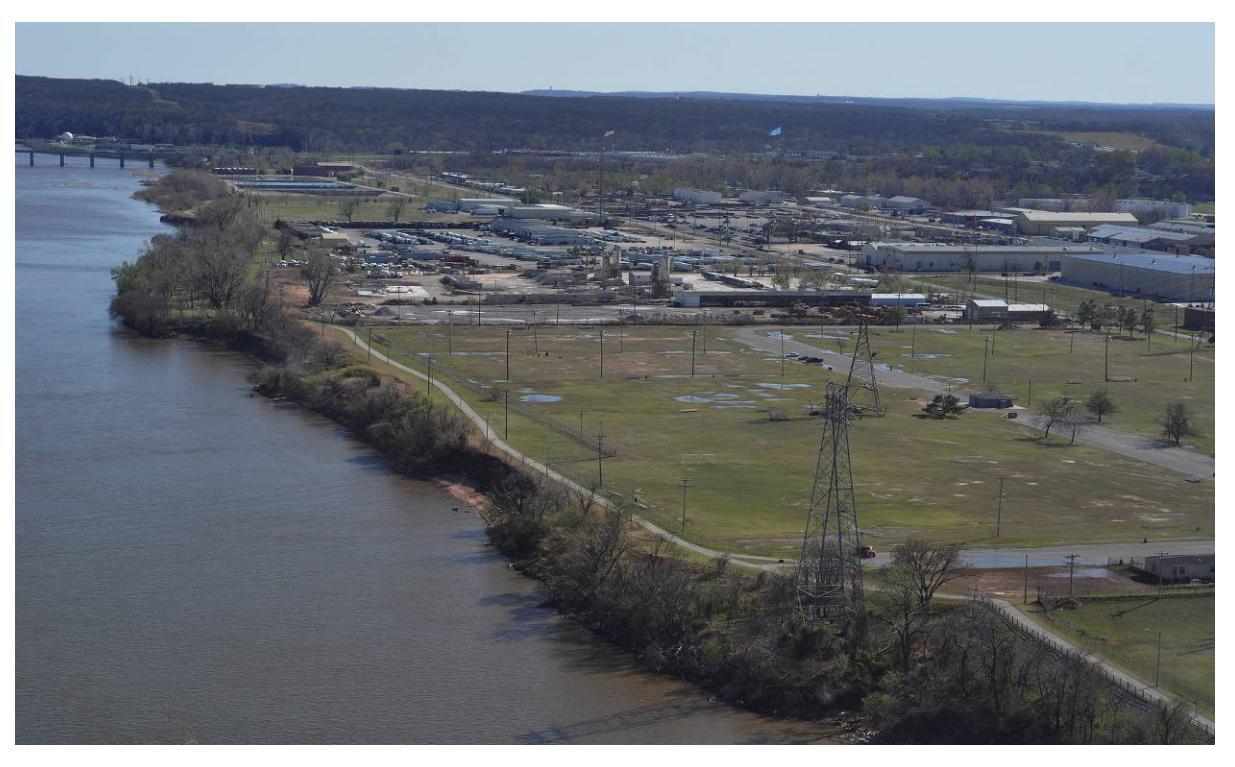
Figure 9. Downstream View of Westbank Soccer Complex and Industrial Areas on West Shoreline

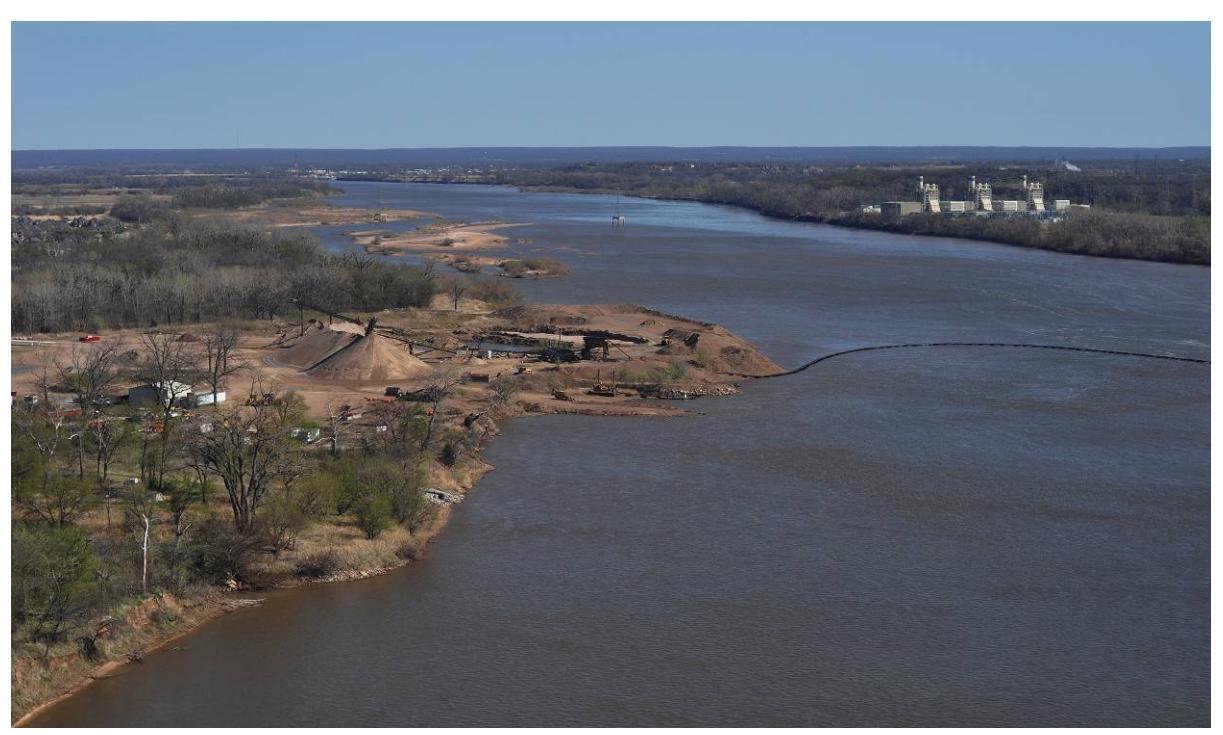
Figure 10. Downstream View from Vicinity of Polecat Creek Confluence

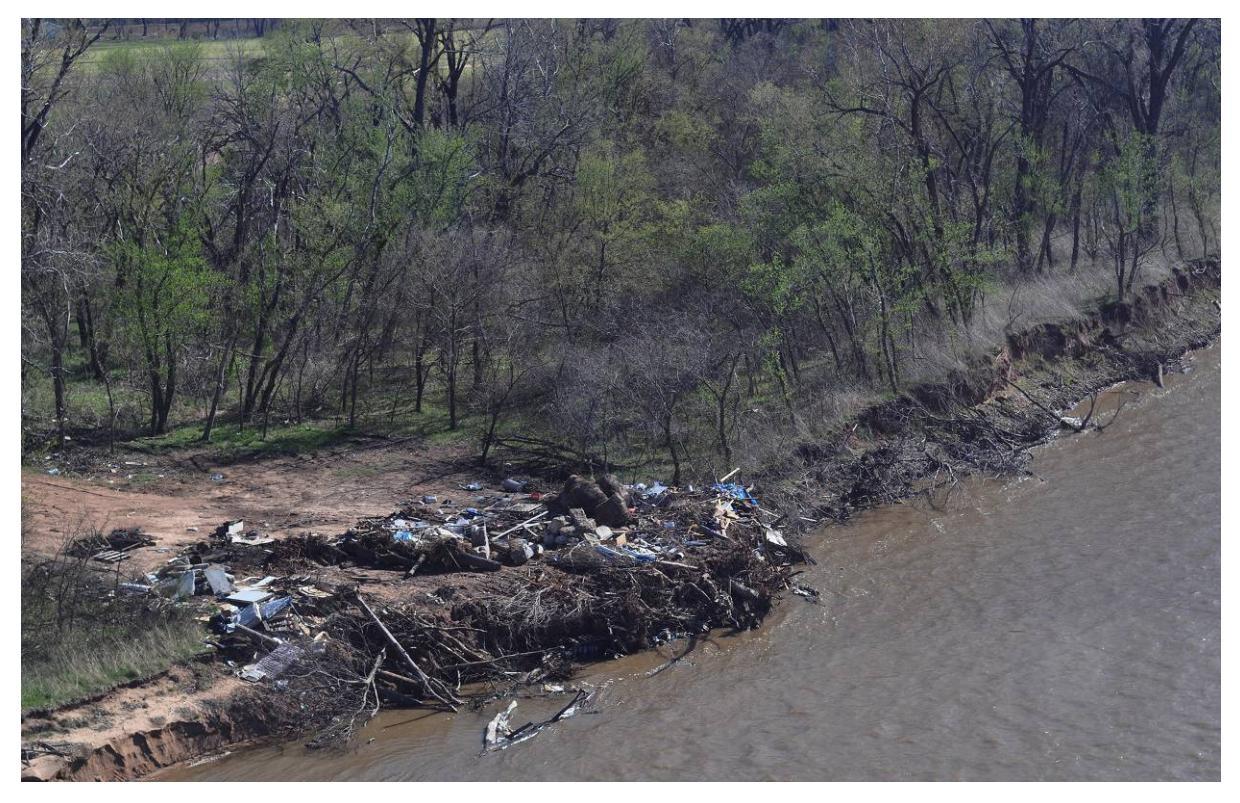
Downstream of the Creek Turnpike bridge and Jenks, the floodplain is broad and sandy as the river extends away from the urban development and levees of the Tulsa area and enters the plains topography of the Osage Cuestas ecoregion (Figure 10). The floodplains are occupied by sod farms, other agricultural lands, sand mining and other limited industrial operations, patches of woodlands, and rural residential areas. Riparian vegetation occurs as bands or patches of trees or shrub/herbaceous vegetation along the shoreline or exposed sand bars at wide bends in the river. Riparian zone excavation and dumping of trash, tires and other debris occurred in several areas along the river near Bixby (Figures 11 and 12).

During the review, several illicit dumps were identified throughout the study area. A combination of residential, industrial and commercial waste was observed.

Figure 11. Trash Dump in Riparian Forest along Shoreline East of Bixby

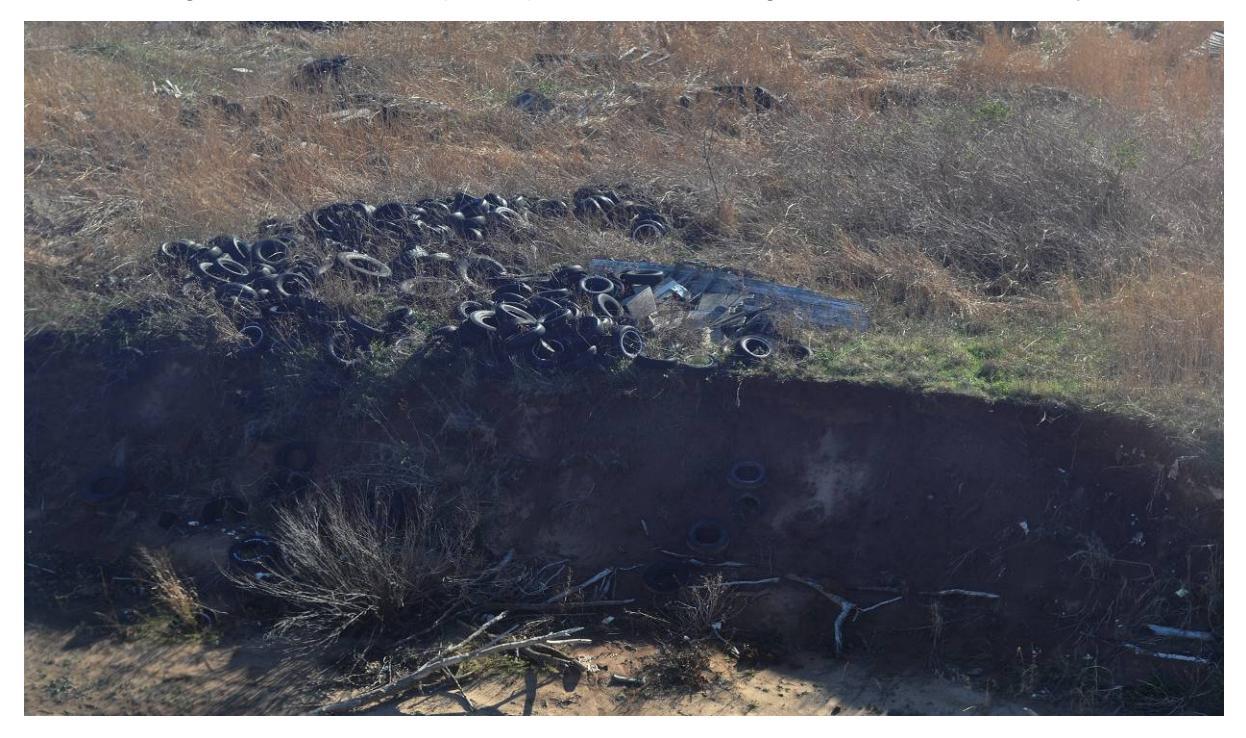
Figure 12. Tire Dump along Shoreline East of Bixby

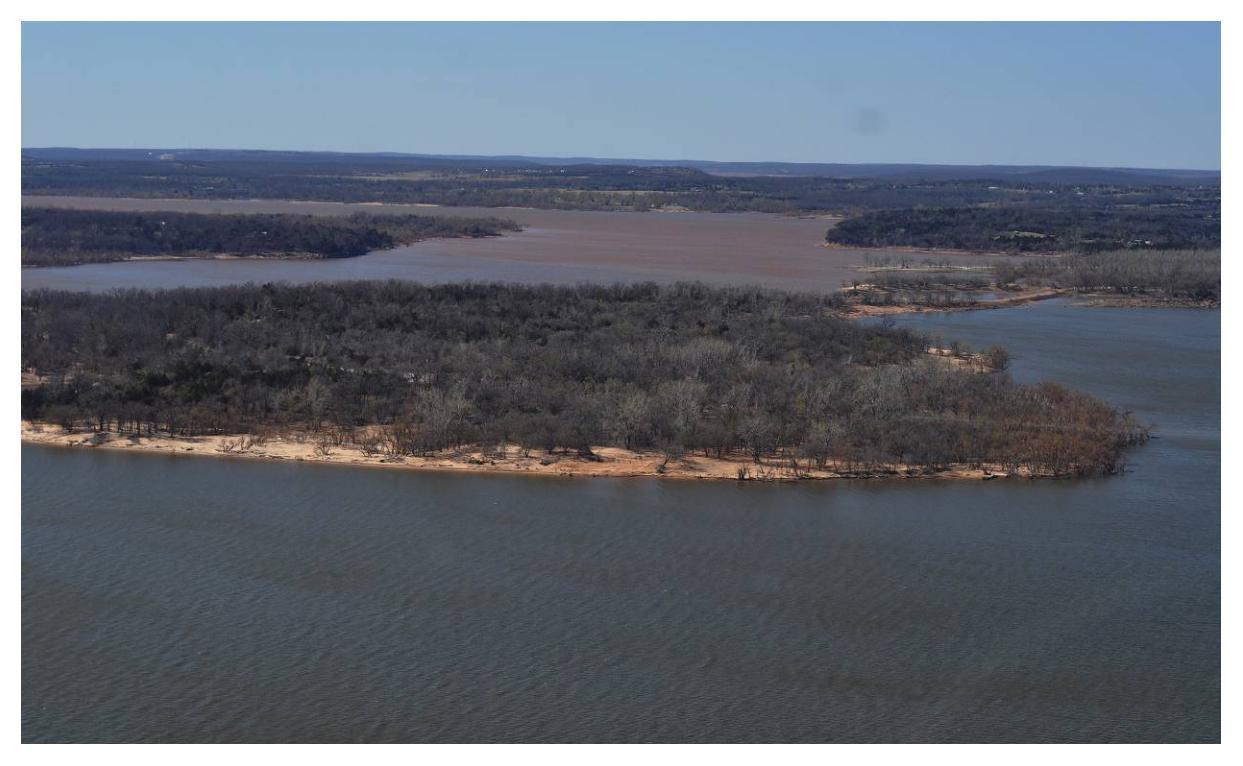
The lower end of Keystone Lake was observed by helicopter at the confluence of the Arkansas River entering from the north and the Cimarron River meandering in from the south. The turbid red color of the Cimarron River stood in contrast to the blue-green color of the Arkansas River (Figure 13), indicating differing upstream watershed characteristics and water quality between the two rivers.

Figure 13. Turbidity Entering Keystone Lake from Cimarron River Arm

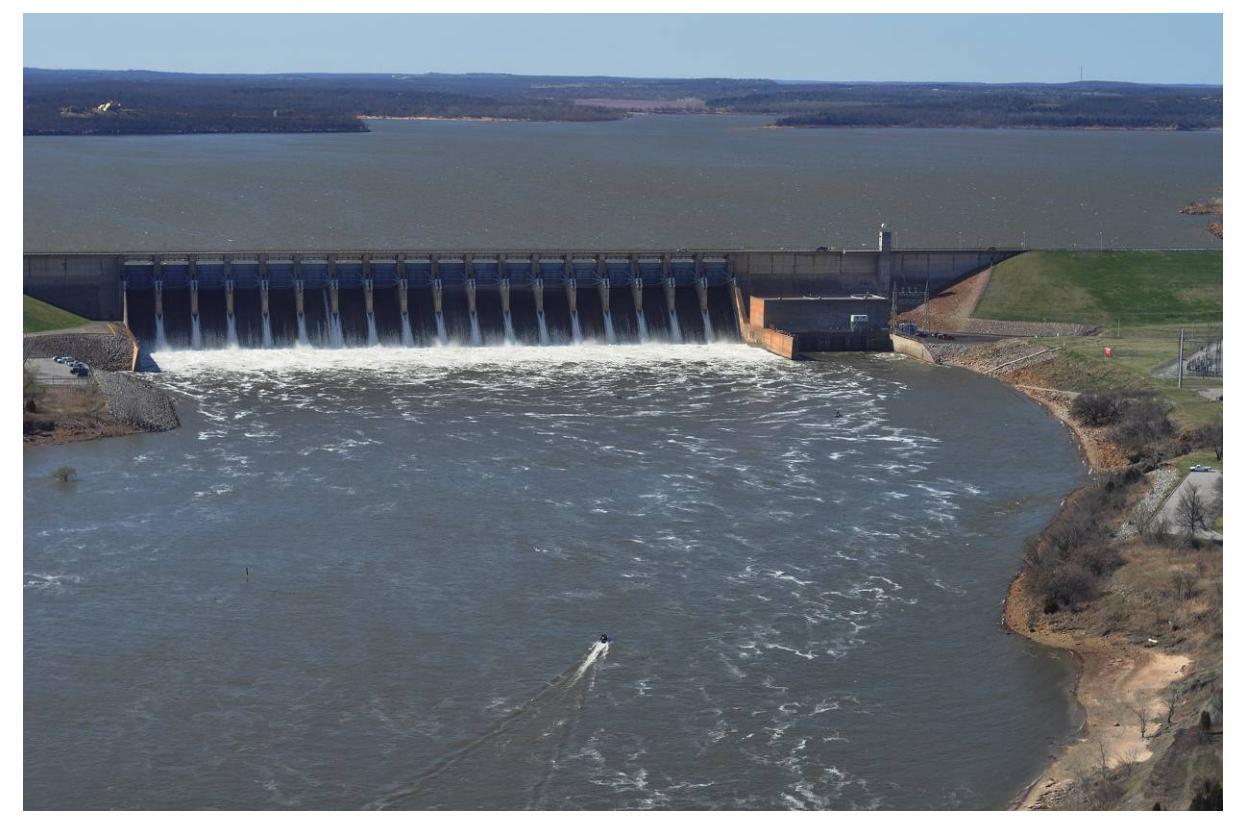
At the time of the survey, water was being released through the gated spillway section of Keystone Dam (Figure 14). At the estimated flow of 30,000 cfs, the Arkansas River channel throughout the study area was wetted across its entire width, with the exception of exposed sand bars at wide bends in the river and occasional larger sand bars in the middle of the channel.

Figure 14. Upstream View of Keystone Dam on March 31, 2009

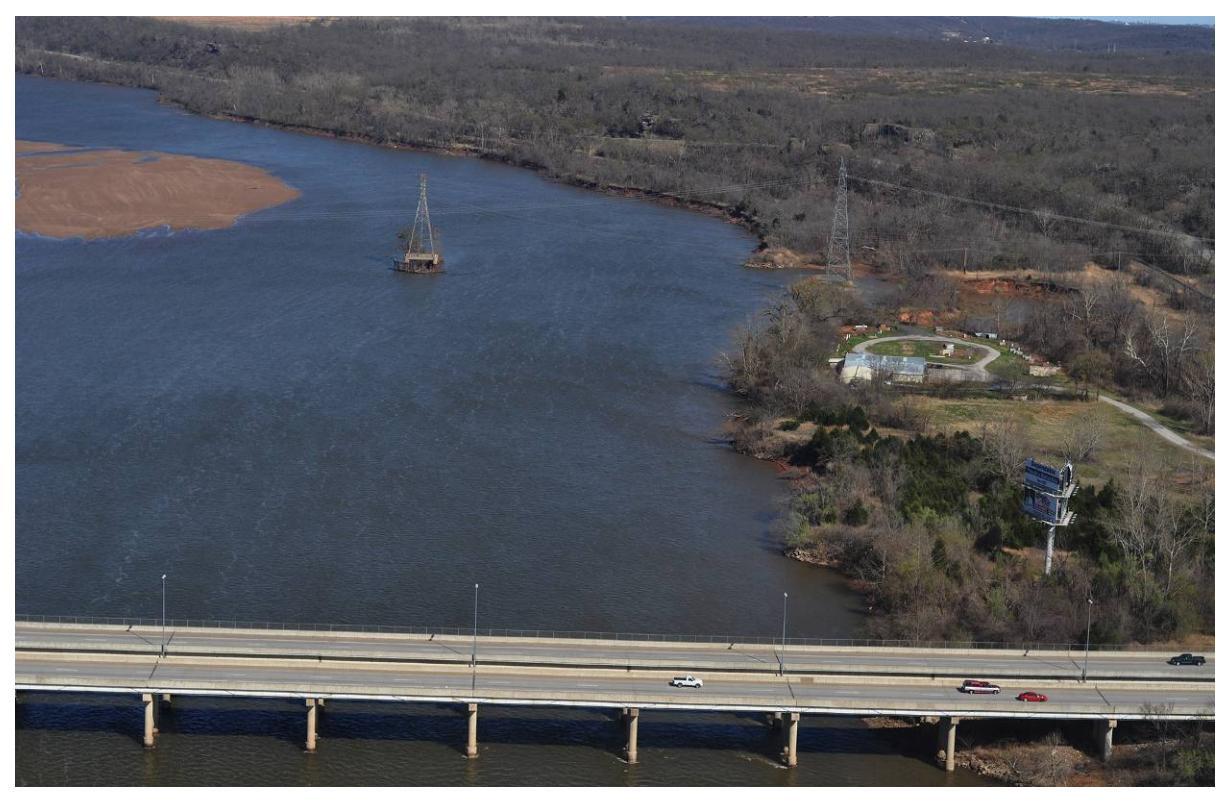
Figure 15. Downstream View of Proposed Site of Low-head Dam at Sand Springs

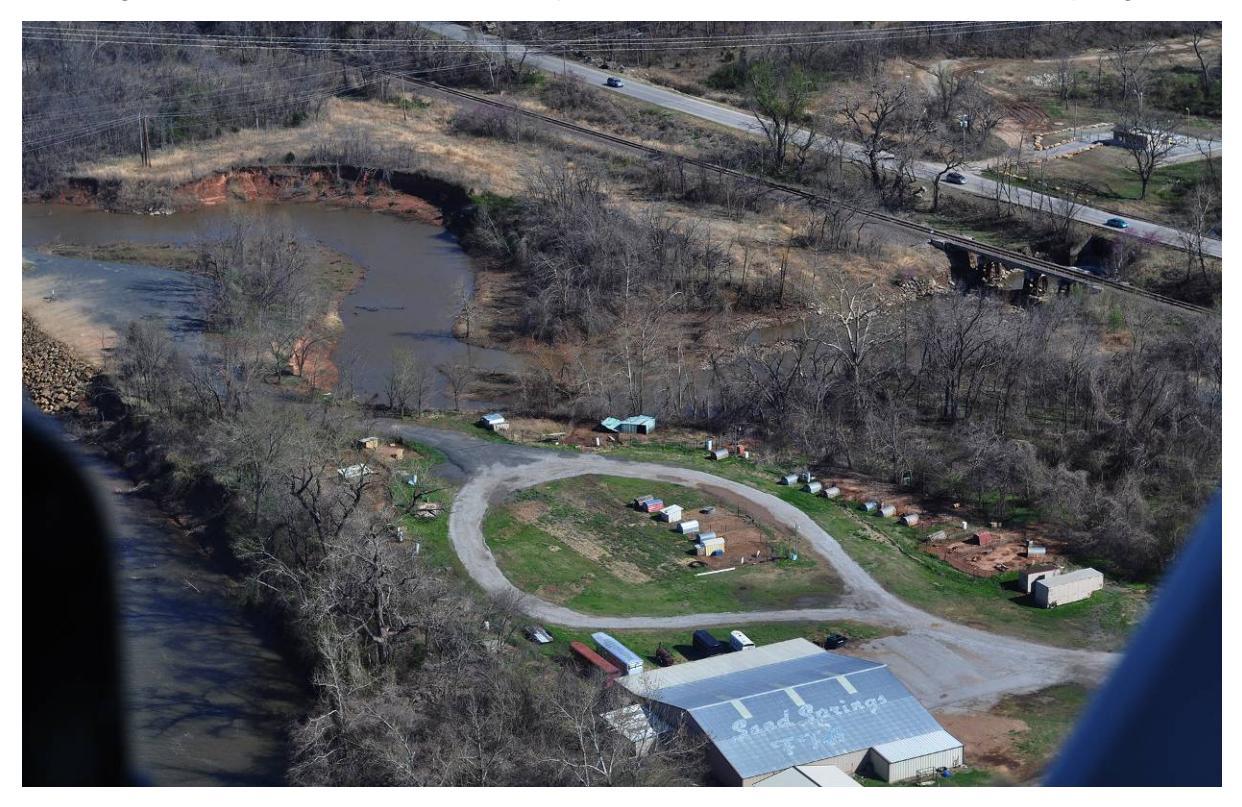
Prattville Creek, which enters from the south just downstream of Highway 97 and the proposed site of the Sand Springs low-head dam, was noteworthy for its active severe erosion and bank failure in the lower meander approaching the river (Figure 16). The existing narrow peninsula of eroding land between the creek and the river would pose a potentially significant constraint to dam design and construction at this location. However, reconfiguring and stabilizing this confluence area would present an opportunity for restoring riparian habitat as part of the project design.

Several electrical utilities lines are located within the river corridor. A high-power transmission line crosses the river near the confluence of Prattville Creek and is threatened by severe erosion.

Figure 16. FFA Hog Farm and Eroding Banks of Prattville Creek next to Proposed Site of Low-head Dam at Sand Springs

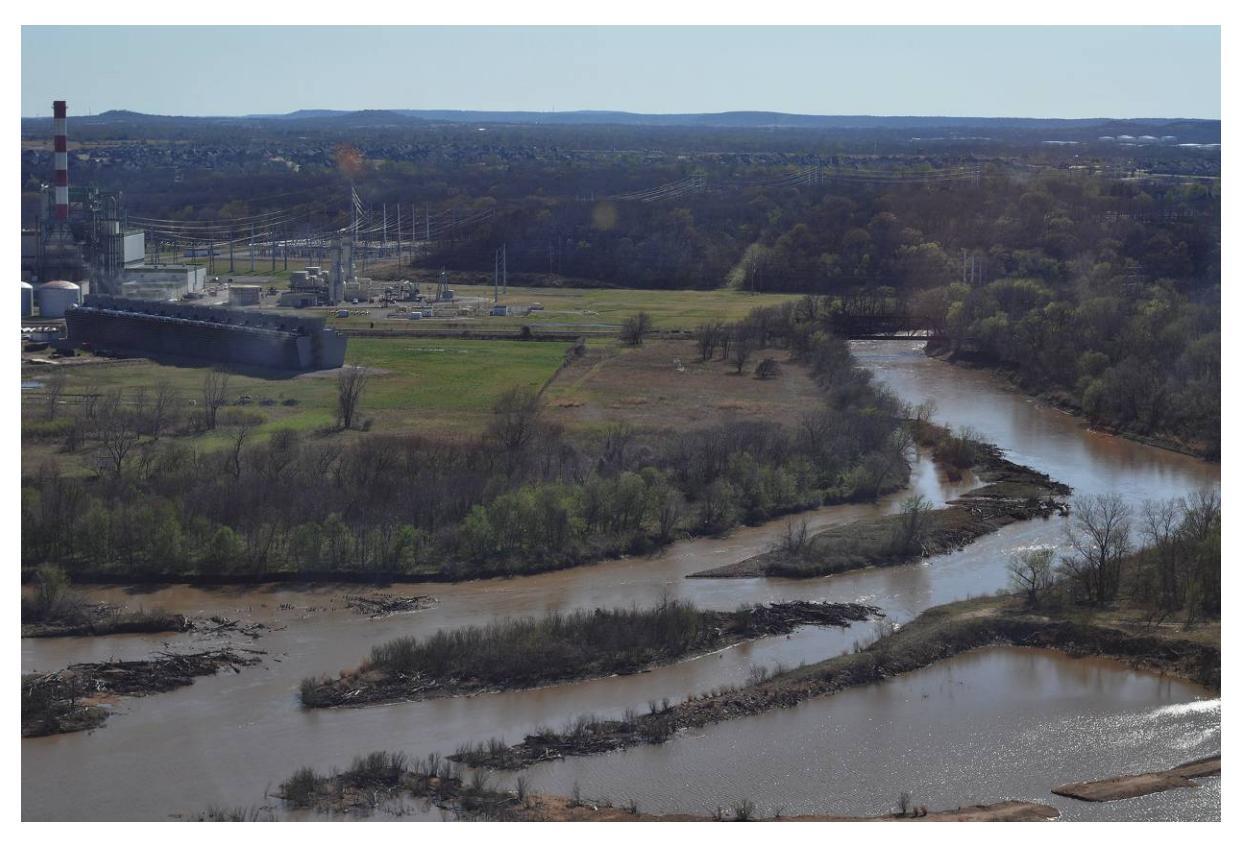
Polecat Creek, which enters from the west just downstream of the proposed site of the South Tulsa/Jenks low-head dam, also has a highly unstable, eroding stream channel, which apparently conveys high volumes of stormwater (Figure 17). The instability of this tributary confluence and the filling and grading of the adjacent floodplain site (formerly occupied by a sand mining operation) (Figure 18) would pose constraints to dam design but could also present stream restoration opportunities.

Figure 17. Polecat Creek approaching its Confluence with the Arkansas River in Jenks

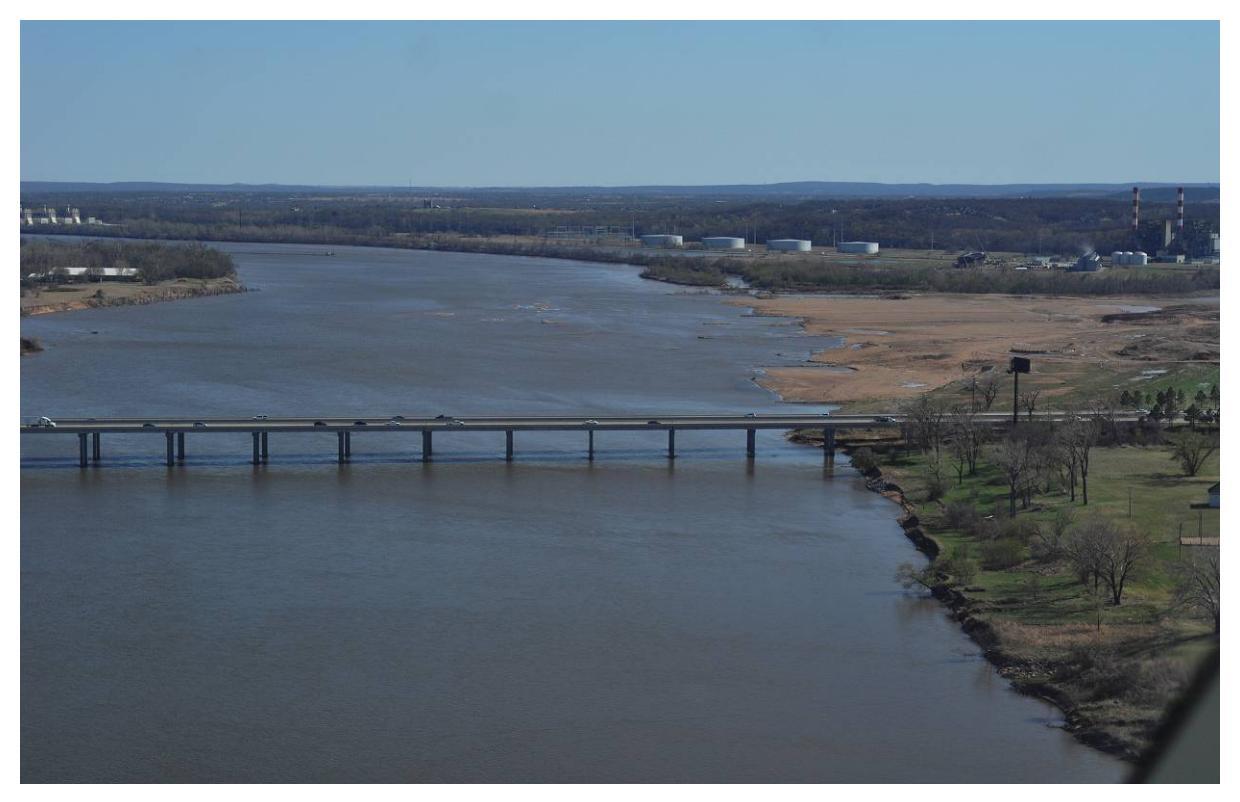
Figure 18. Downstream View of Proposed Site of Low-head Dam at Jenks

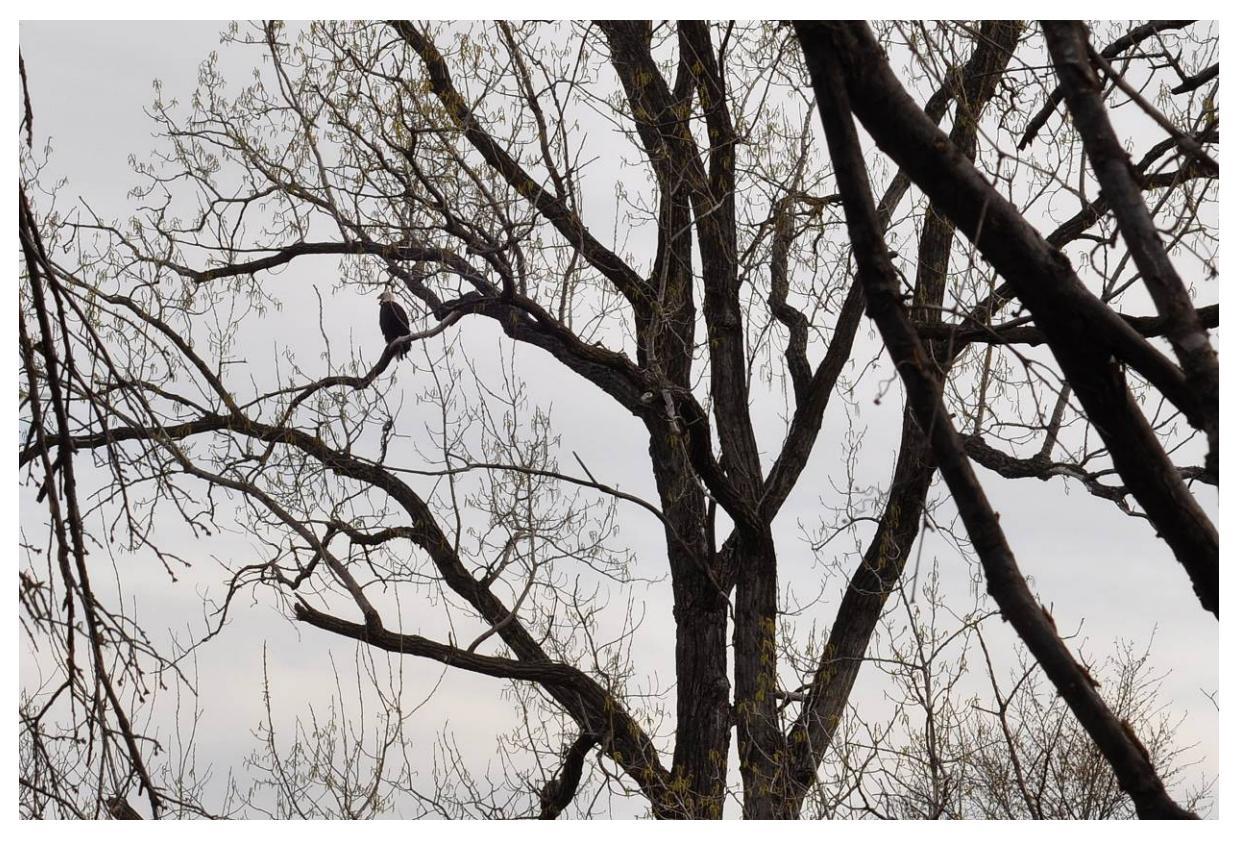
Several bald eagle nests and at least two bald eagles were observed along the river between Keystone Dam and Sand Springs (Figure 19). Large trees suitable for nesting were most abundant in the upper portion of this reach (e.g., Swift Park). An active nest also was observed near the Sand Springs industrial area along the north shoreline. Another bald eagle nest was observed in a large tree along the reach between Bixby and the county line.

Figure 19. Bald Eagle Perched in Tree at Swift Park along the South Shoreline

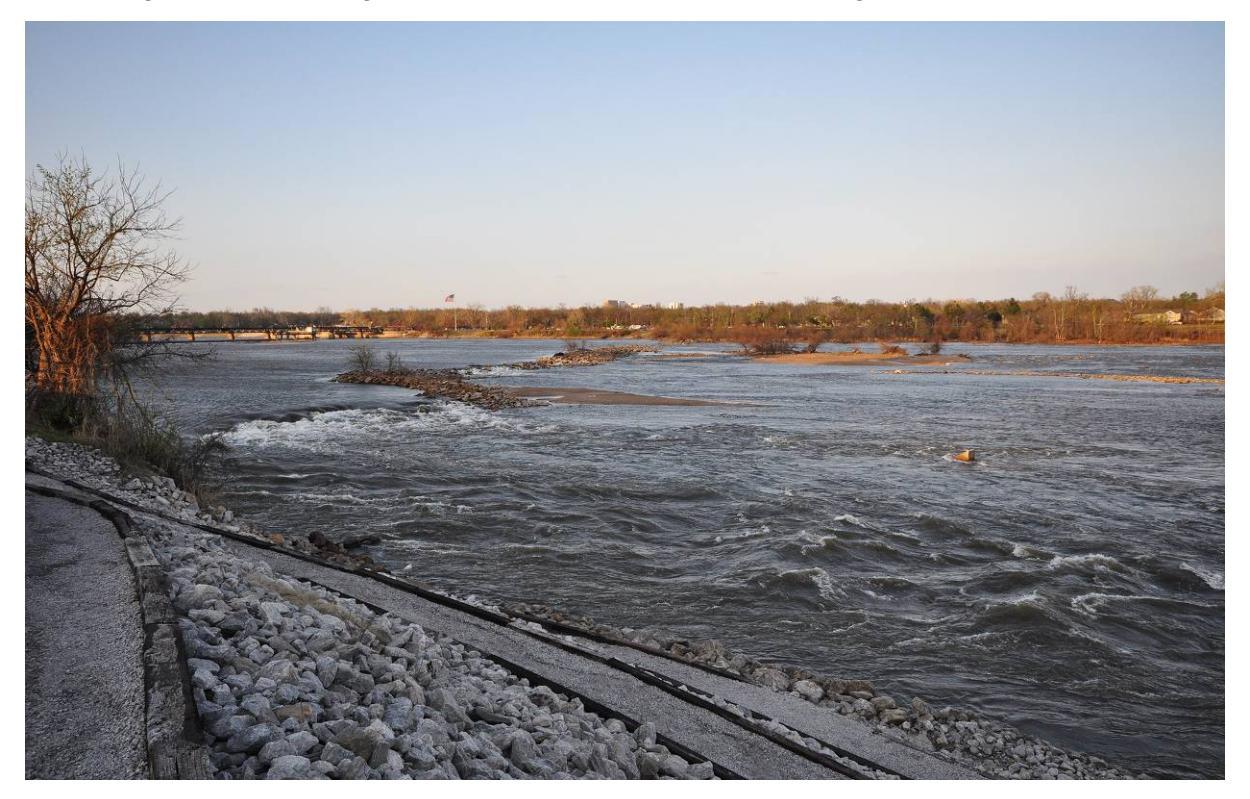
At the observed river flows, little variation was evident in riverine aquatic habitat, with the exception of the swift water below Zink Dam and the remnants of a relocated rock dam immediately downstream, which included the Tulsa Wave (Figure 20). Anglers were observed during the site reconnaissance along the bank at Tulsa Wave Park, along the bank and on the fishing platform at Zink Dam, and along both banks and in boats in the tailwater of Keystone Dam (Figure 21).

Figure 20. Upstream View of Tulsa Wave (Foreground) and Zink Dam (Background)
