Arkansas River Corridor Projects Site Reconnaissance Summary

TO:	Tulsa County
COPIES:	File
FROM:	CH2M HILL
DATE:	April 30, 2009
PROJECT NUMBER:	386594

This Technical Memorandum describes the site reconnaissance activities and summarizes the findings relative to potential human and natural environmental constraints to the conceptual design and permitting of the proposed project.

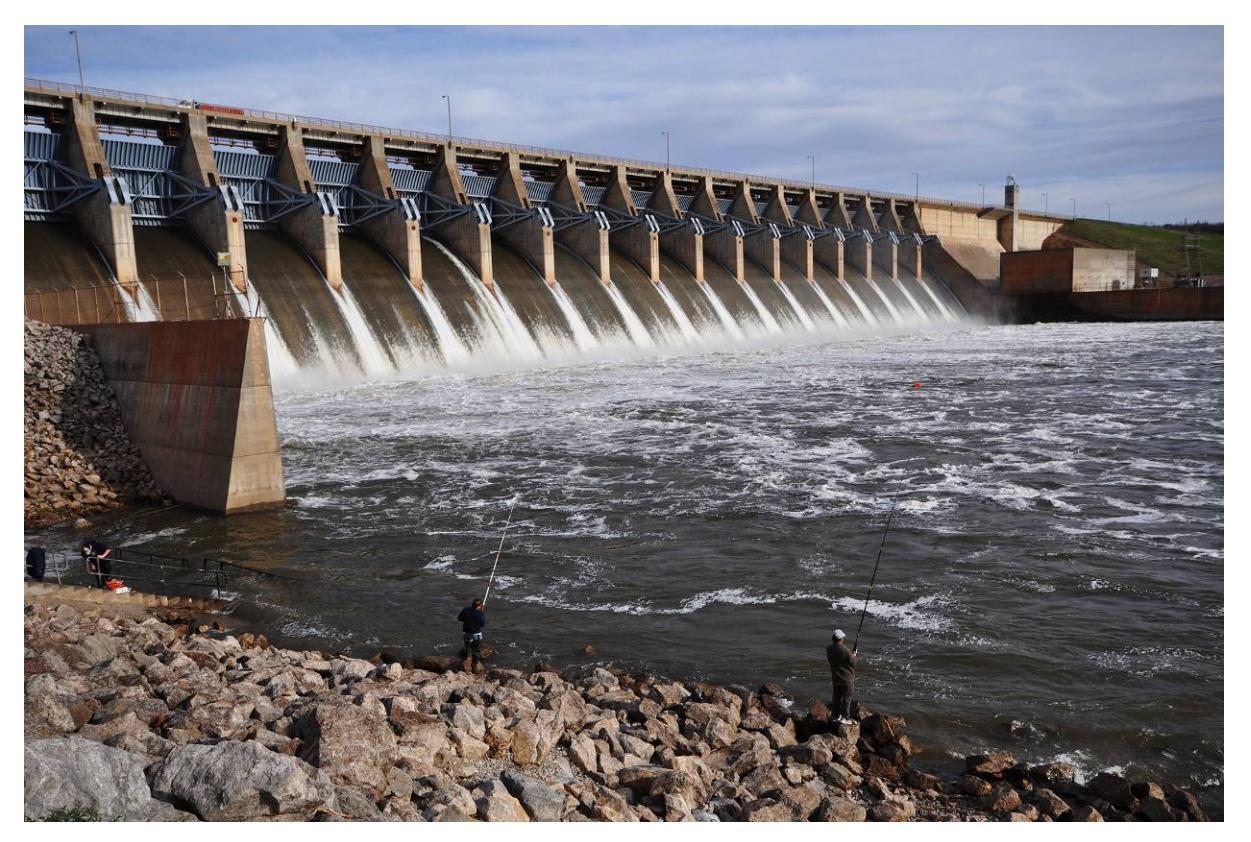
At the observed river flows, little variation was evident in riverine aquatic habitat, with the exception of the swift water below Zink Dam and the remnants of a relocated rock dam immediately downstream, which included the Tulsa Wave (Figure 20). Anglers were observed during the site reconnaissance along the bank at Tulsa Wave Park, along the bank and on the fishing platform at Zink Dam, and along both banks and in boats in the tailwater of Keystone Dam (Figure 21).

Figure 21. Keystone Dam and Tailwater at White Water Park
